PHASE I INSPECTION
JESSE BYRD DAM
HAYWOOD COUNTY, TENNESSEE

PHASE I INSPECTION REPORT
NATIONAL DAM SAFETY PROGRAM
TENNESSEE

Name of Dam	Jesse Byrd Dam
County	Haywood
Stream	Tributary South Fork Forked Deer River
Date of Inspection	May 14, 1981

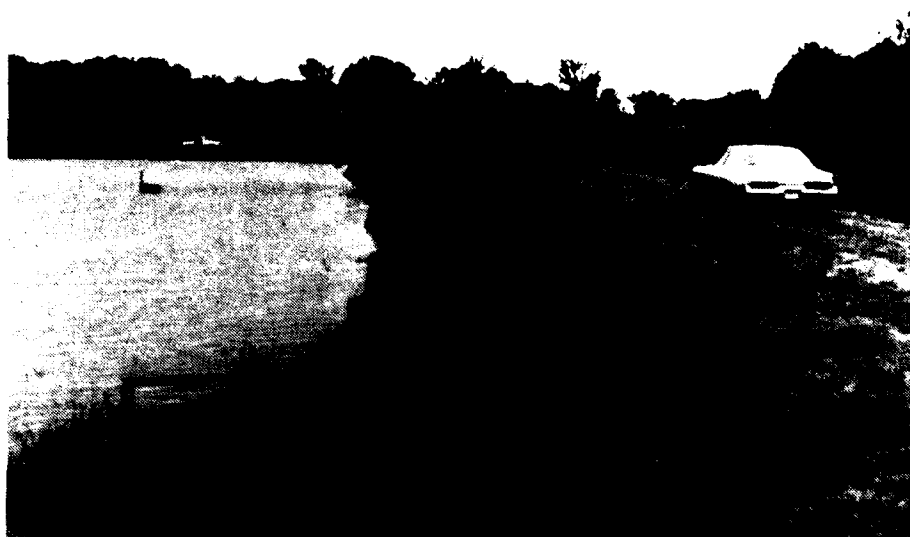
1. Top and upstream slope of Byrd Dam. Note emergency spillway at upper left.

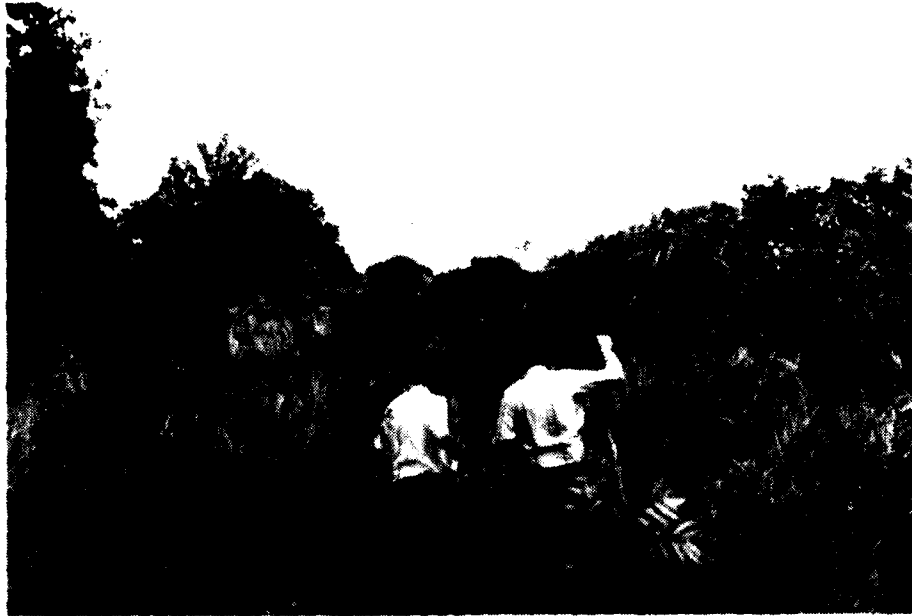
- b. On the basis of engineering judgment and visual observation, both the upstream and downstream slopes appear to be stable.
- c. High vegetation, found on the downstream slope, made observation of the slope difficult and possibly hid other deformities.

3. Height of vegetation on backslope made close observation of slope difficult.

the tall grass and saplings on the backslope should be removed and the backslope inspected in detail after their removal. The gulleying of the backslope of the emergency spillway should be filled in and seeded to effectively eliminate the gulleying of the exit slope. The springs in the east abutment should be monitored and if they should continue to flow to the driest part of summer, remedial measures should be taken to correct this situation. The service spillway structure should be maintained to keep the corrugated metal pipe from rusting through and setting up piping conditions under the dam.

- a. Inspect the downstream slope for any indications of failure.
- b. Investigate the cause of seepage in the east abutment and suggest remedial measures if necessary.
- c. Investigate the service spillway structure and recommend remedial measures.

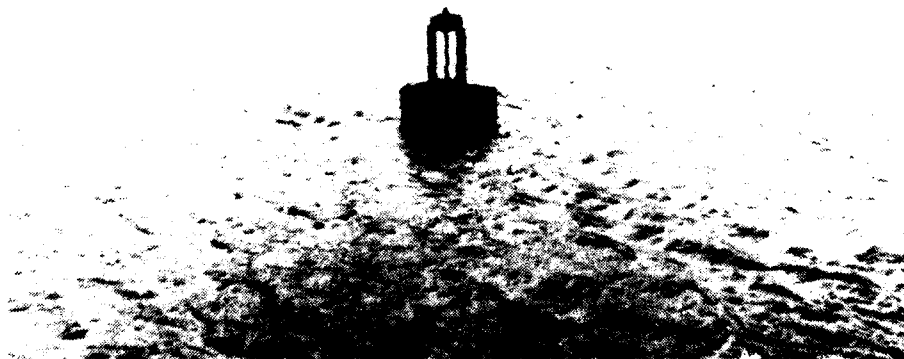
4. Service Spillway Byrd Dam.

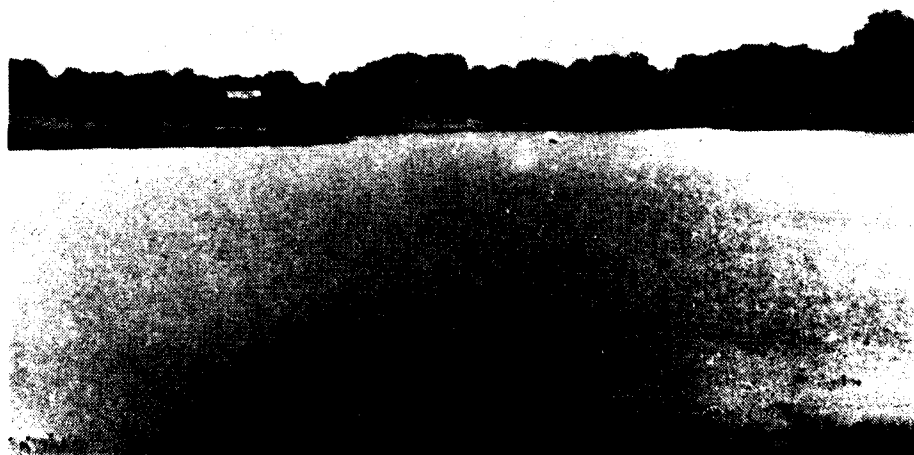
8. Byrd Dam impoundment.
